DR2E Corrections

HF I/Q SDR Receiver DR2E
30 kHz-40 MHz YU1LM/QRP

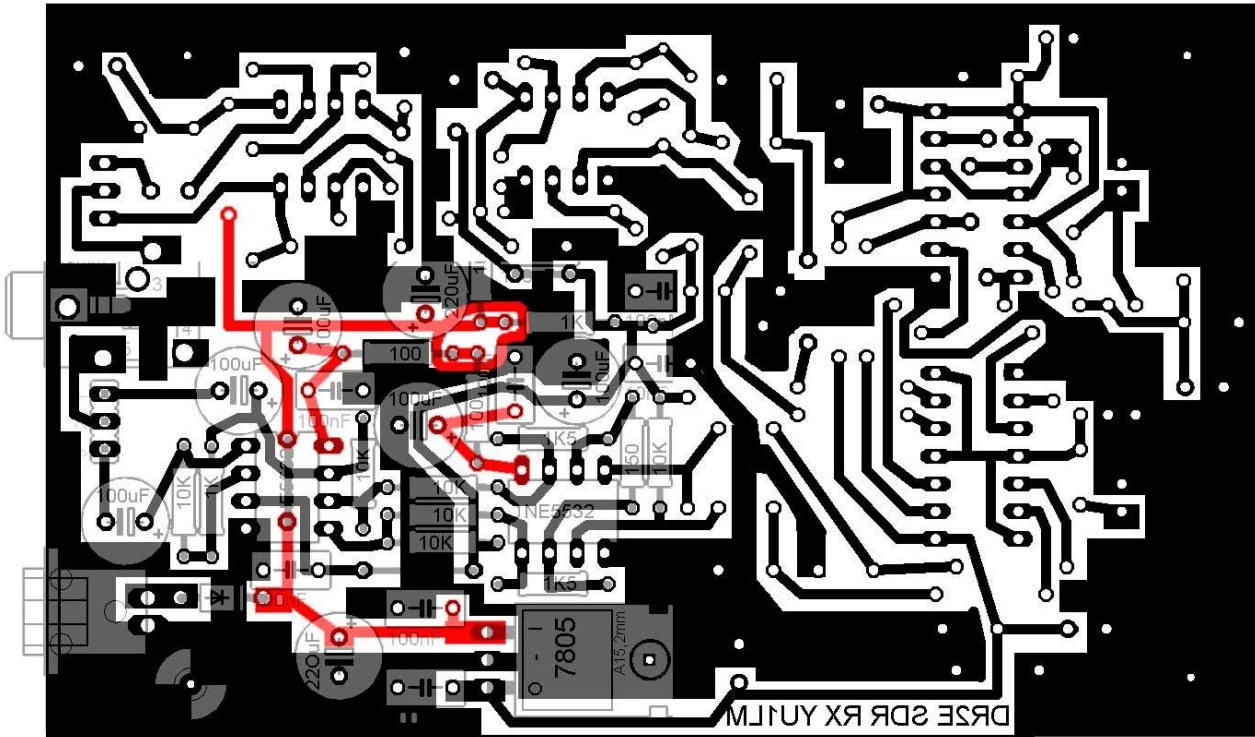
I missed connection for power supply IC7, IC5 and output C23 100uF. Corrected new version of PCB and Schematic are down.
